CONNECTICUT RIVER BASIN
LUDLOW, VT

JEWELL BROOK DAM SITE NO. 3
VT 00016
VT 00262

PHASE I INSPECTION REPORT
NATIONAL DAM INSPECTION PROGRAM

APRIL 1980

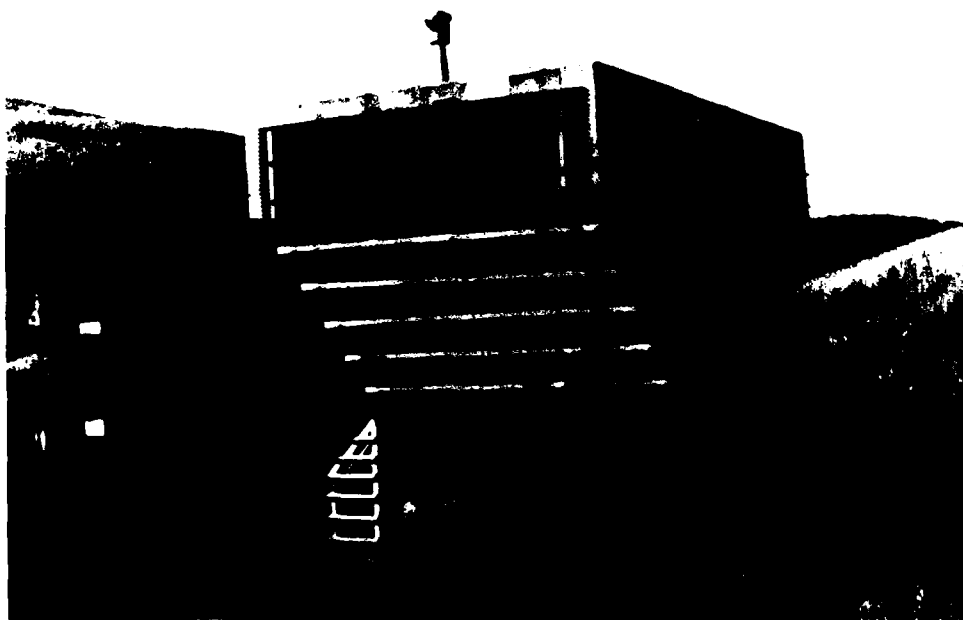
The intake structure (Photo 12) is in good condition. The concrete shows no signs of cracking or of efflorescence. The condition of the steel trash racks is good. Access to the top of the tower is provided by a makeshift rope ladder in poor condition. Because of the auxiliary recreational use of this structure it is suspected that the rope ladder was installed by persons other than the owners.

#12 PRINCIPAL SPILLWAY RISER

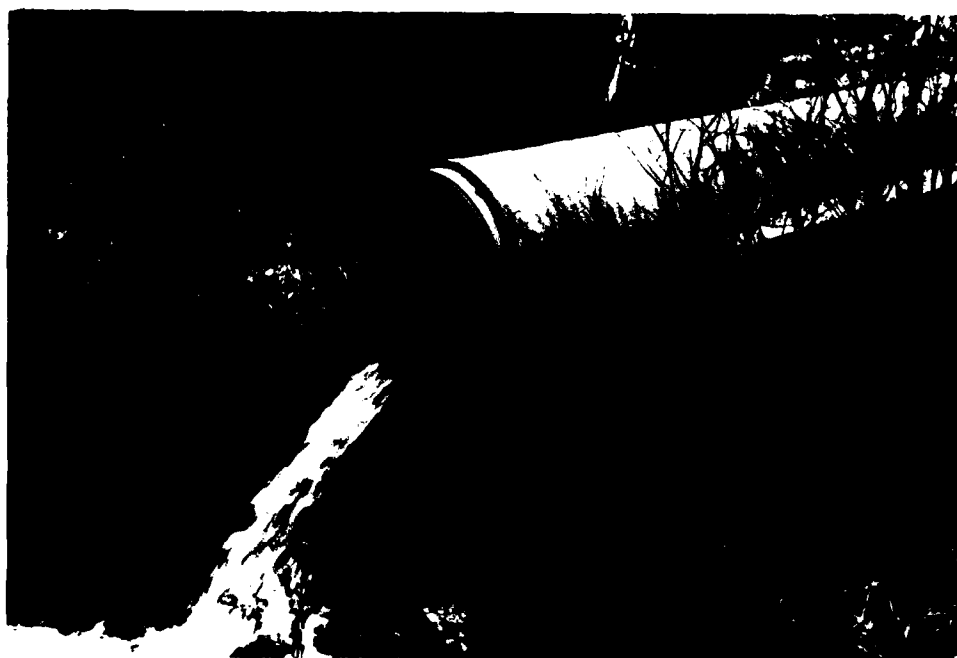
The outlet conduit is exposed approximately 25 feet at the discharge end (Photo 13). Minor efflorescence was observed on the cradle which supports the outlet end of the concrete conduit. A hairline crack with efflorescence was detected at the downstream conduit joint but no seepage was evident. The condition of the conduit is generally good (Photo 14).

#14 DISCHARGE OF OUTLET CONDUIT
